SMU-UNHCR

Partnership in Research for Water Sanitation
and Hygiene

2011 Final Report

Executive Summary

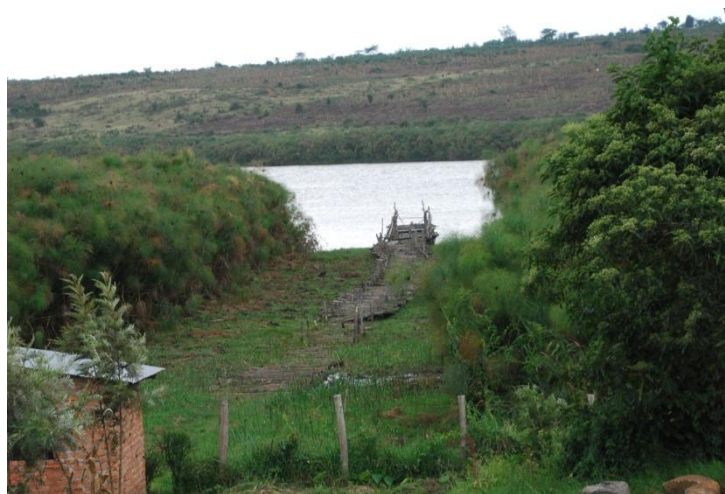
Figure 4.1 Nakivale: Surface water used in treatment plant

The sampling team met up with the implementing partner's (Deutsche Gesellschaft für Internationale Zusammenarbeit, or GIZ) Nakivale representative, Jean Baptiste, upon arrival on the afternoon of 12 August. The first location toured by the team was the surface water (Figure 4.1) and the adjacent treatment plant (Figure 4.2) used to treat its water. The surface water was directly sampled from the makeshift pier shown in Figure 4.1 (*i.e.*, untreated water). The tap (*i.e.*, post-treated water) was then sampled as well.

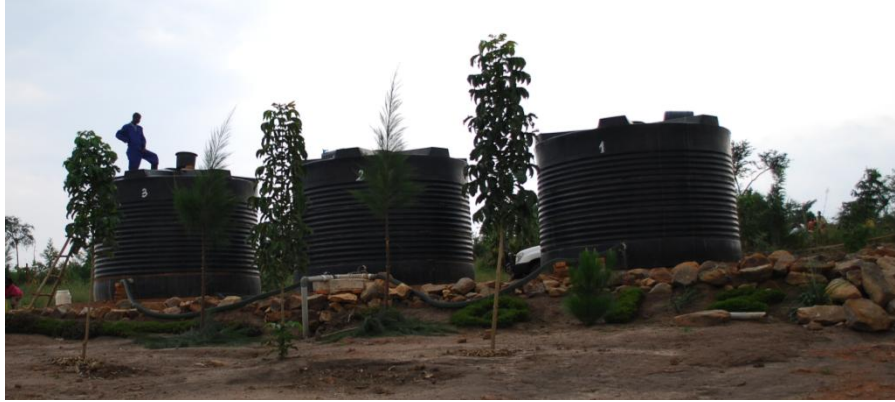
Figure 4.2 Nakivale: Surface water treatment and storage tanks

The surface water was mechanically pumped from the lake into the tanks shown in Figure 4.2. Chlorine was then added by hand at a dose of 150 g of chlorine per 20 m³ water (Figure 4.3). The residual chlorine was mentioned by Mr. Baptiste as approximately 0.3 mg/L at the tap. Alum was also added to promote coagulation and flocculation. The water was then gravity-fed to the taps for refugee consumption.

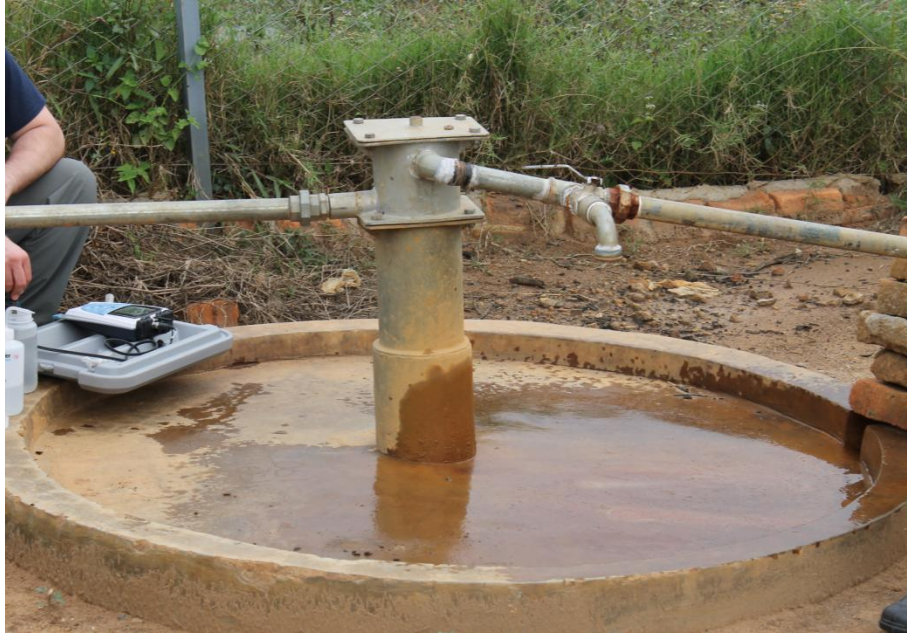
Figure 4.5 Nakivale: Mechanized borehole tap

Other sources seen in Nakivale utilized boreholes and shallow wells. Most were equipped with manual hand pumps with the exception of one mechanically pumped borehole (Figure 4.5). The pump then fed a tap; both the pump and tap, however, were guarded by a chain-link fence and locked gate.

The water from this mechanized borehole, however, was extremely turbid (Figure 4.6). This particular borehole, whose pump is powered by a generator, is 70 m in depth yielding 3 to 4 m³ per hour.

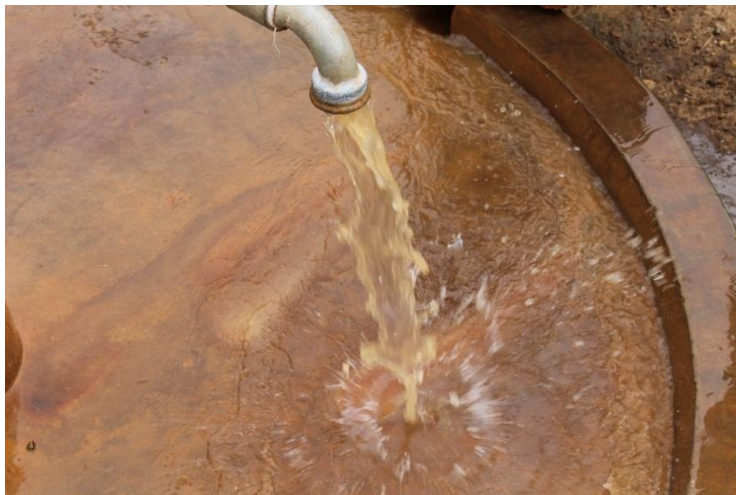
Figure 4.6 Nakivale: Turbid water flowing from tap

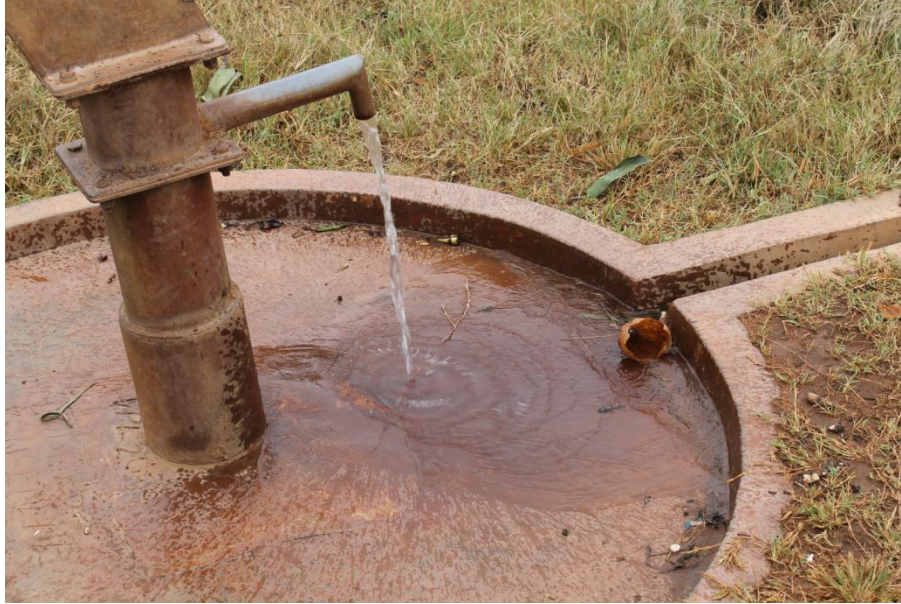
A common complaint by the refugees encountered by the team in Nakivale was the taste of the water due to its high iron content. This significant iron content is evident by the deep, dark red staining of the concrete aprons circling the borehole hand pumps (Figure 4.7).

Figure 4.7 Nakivale: High iron content evident by dark red staining of concrete apron

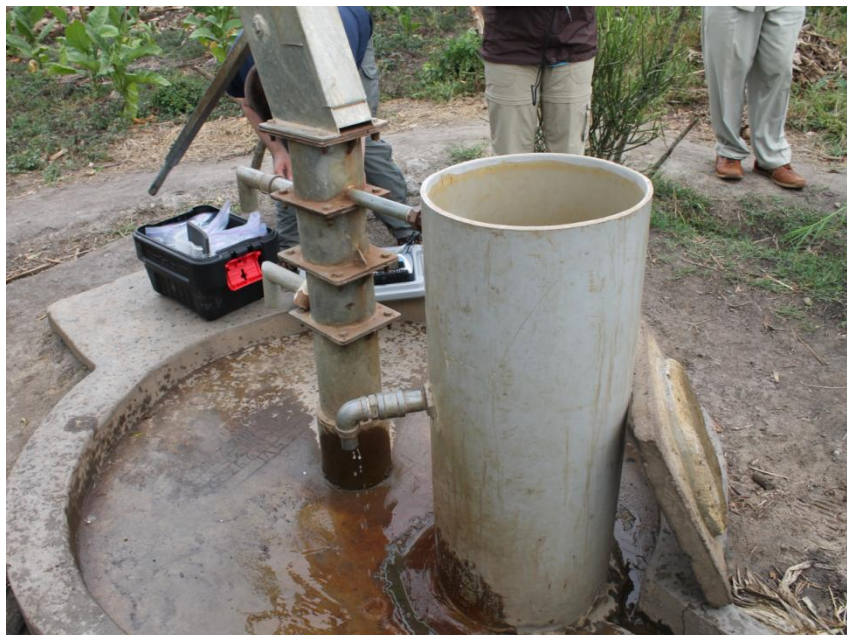
This high iron content was evident on several of the hand pumps encountered by the SMU team. In fact, it was noted that at least two had been completely abandoned due to their extremely high iron content. This problem had been addressed previously. For example, the team encountered a sand and gravel filter in use at one of the hand pumps (Figure 4.8 and Figure 4.9). This filter was attempting to aerate the water as it percolated through the filter in order to remove some of the iron. The efficacy of this filter will be determined by the team by analyzing both pre- and post-filter samples.

Figure 4.8 Nakivale: Filter for iron removal at a hand-pumped well

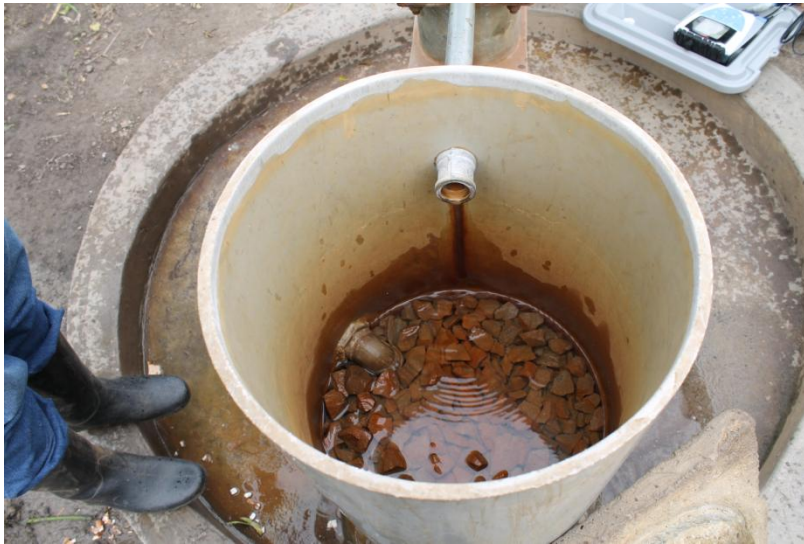
Figure 4.9 Nakivale: Top view of the iron filter at a hand-pumped well

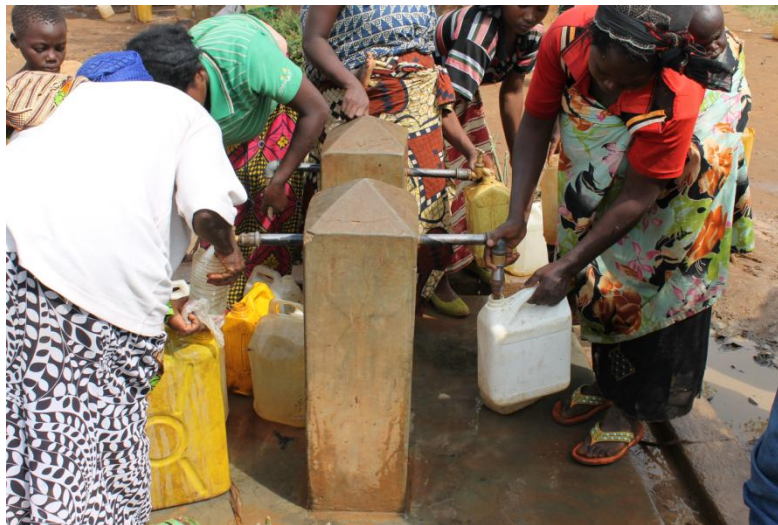
Figure 4.10 Nakivale: Tap stand available to refugees

A total of 16 samples were taken at Nakivale. The team noted that bountiful water was available. A combination of ground- and surface water was used, including certain treatment processes for the surface water. Refugees could also access water from various tap stands (Figure 4.10).

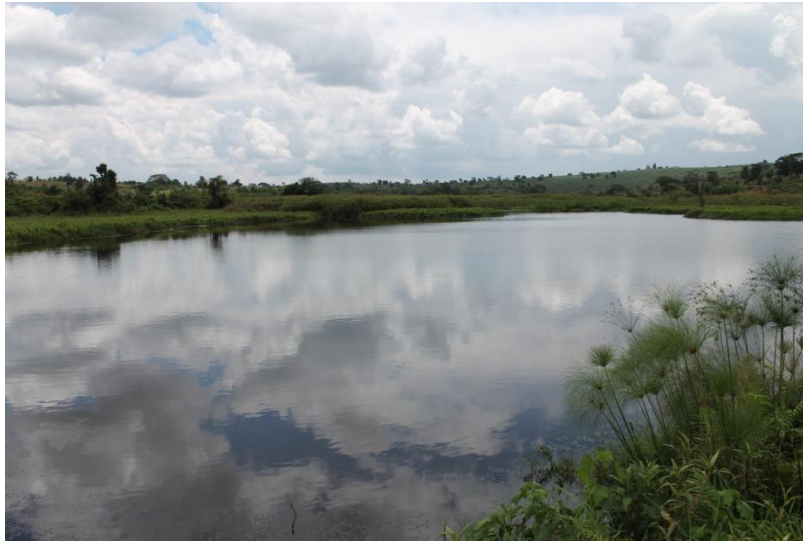
Figure 4.12 Kyaka II: Surface water

The dammed surface water (Sweswe Dam) available is shown in Figure 4.12. The surface water is utilized in the dry season when groundwater yield greatly diminishes. It is trucked to tanks in the village where the water is treated with alum and chlorine.

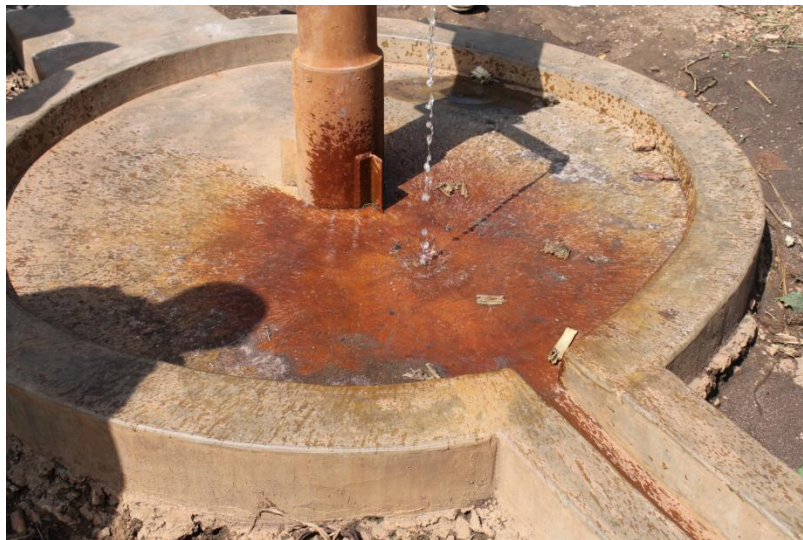
Like in Nakivale, iron was also a common problem and complaint in Kyaka II. Iron contamination was evident on the concrete apron in Figure 4.13. Iron was similarly evident at several of the wells sampled.

Figure 4.13 Kyaka II: Iron-stained concrete apron

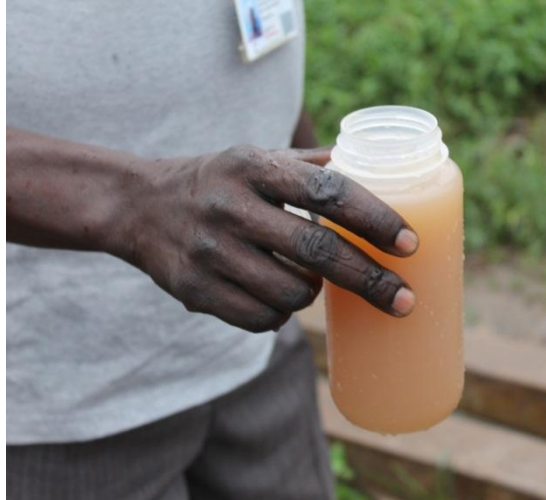
Another problem commonly observed in Kyaka II was high turbidity (Figure 4.14). The turbidity of samples varied spatially. In fact, adjacent wells at times were found to have significantly different turbidities.

Figure 4.14 Kyaka II: High turbidity sample from a borehole

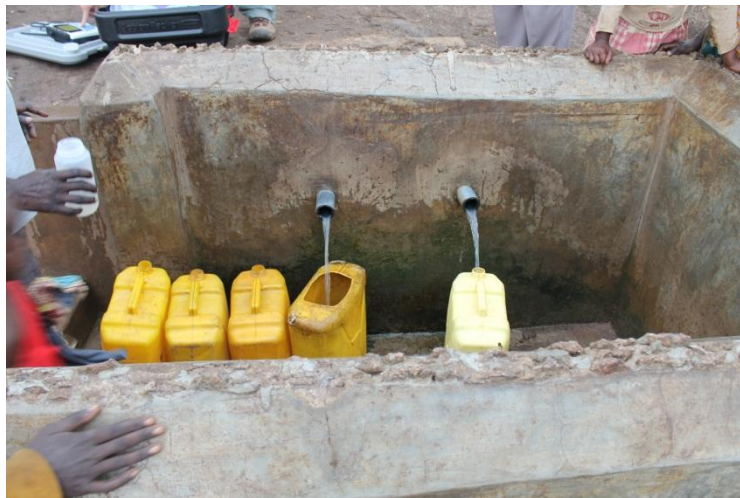
Natural springs were also found and sampled (Figure 4.15). The quality of the springs upon initial observation seems to be quite good: low turbidity, circumneutral pH, and low to average conductivities.

Figure 4.15 Kyaka II: Natural spring well

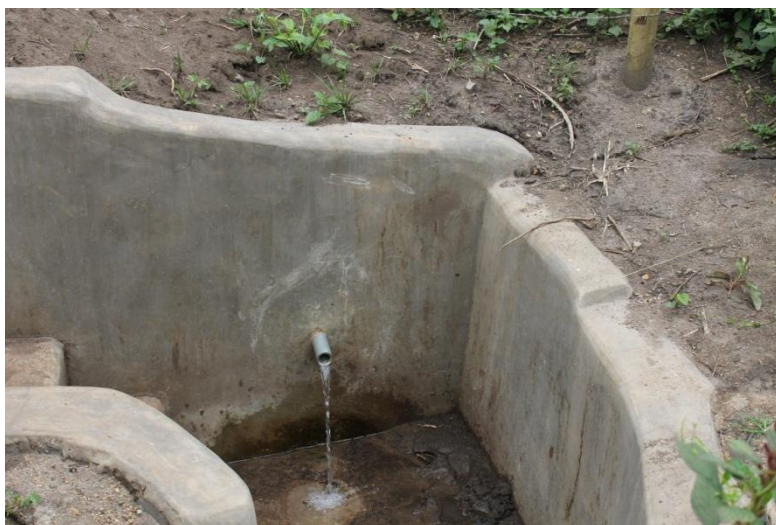
Figure 4.16 Kyangwali: Natural spring

Kyangwali resembled Nakivale and Kyaka II—wells were spread out but water seemed plentiful. Water sources included boreholes and shallow wells, as well as a natural spring (Figure 4.16). The pH ranged from 6.6 to 7.8, a reasonable variation for natural groundwater. Conductivities were well within range of drinking water; none was higher than 1000 $\mu\text{S}/\text{cm}$.

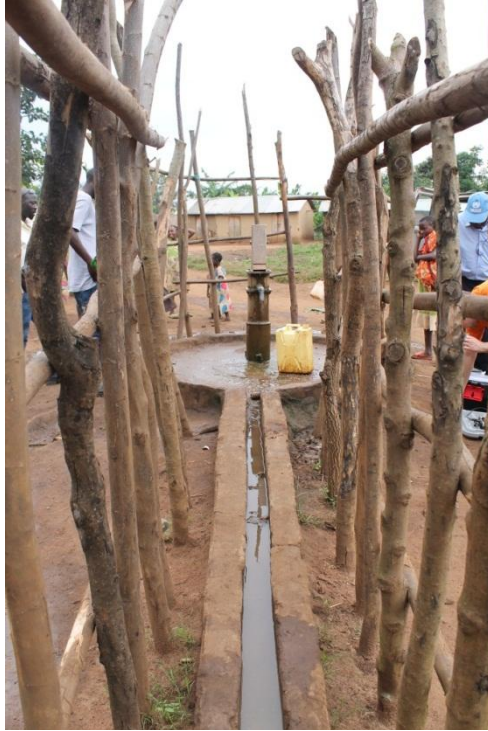
Wells were well maintained by the refugees. Fencing was placed around wells to protect the water points from animals. The areas were also kept free from growth and debris (Figure 4.17). Some discoloration and mud were observed in the cement pours surrounding the wells (Figure 4.18). A few of the wells (*i.e.*, the hand pumps and cement aprons) were noticeably older than others seen both around Kyangwali and around Uganda. The old piping was also causing some discoloration of the water. It was mentioned to the SMU team by those accompanying them through the camp that many of the shallow wells became cloudy after rainfall events. Coliform counts also rose after such events (although this is beyond the scope of this project). A total of 19 samples were collected from Kyangwali.

Figure 4.17 Kyangwali: Protective fencing around a hand-pumped well

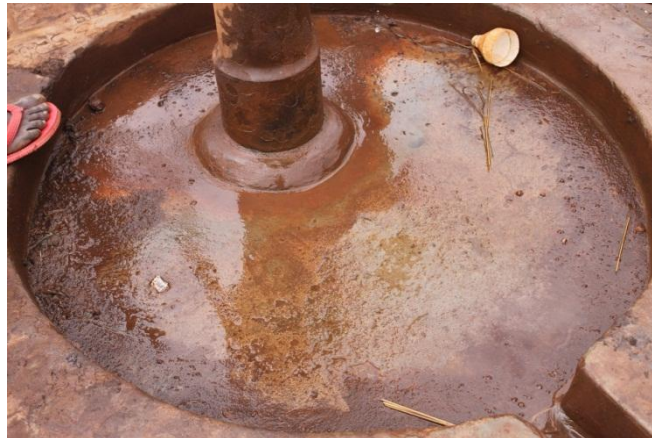
iron contamination; however, there was significant discoloration observed across the camp, which was evidence of iron contamination similar to that seen in Nakivale and Kyaka II (Figure 4.19). Many of the samples were extremely turbid and discolored, as seen in Figure 4.20. Overall pH values were slightly higher in Kiryandongo, averaging between 8.0 and 8.5. These pH values were still within the range of natural groundwater.

Figure 4.19 Kiryandongo: Severe discoloration by iron

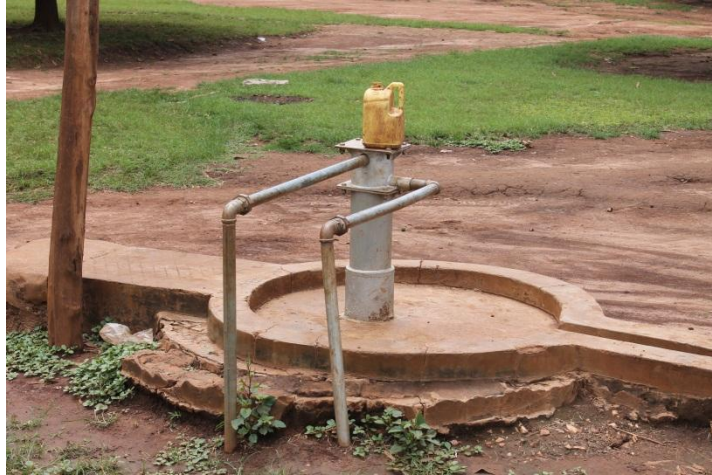
Figure 4.21 Kiryandongo: Mechanized borehole

The use of mechanized boreholes (Figure 4.21) was employed to pump water to larger holding tanks for use in the health center of the settlement. This water was then piped to various tap stands throughout the area (Figure 4.22). There were a couple of sites visited that were intended to be sampled but were not operational. Several of the boreholes were also described by others as “old”.

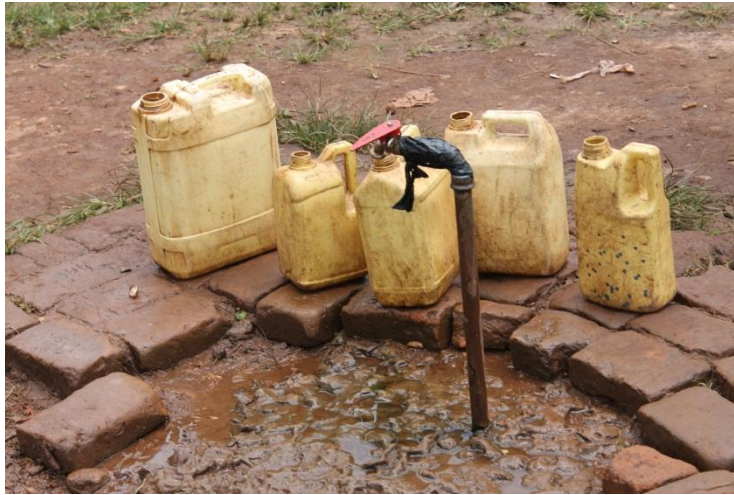
Figure 4.22 Kiryandongo: Tap stand for mechanized borehole

The sites in Kiryandongo did not seem as well maintained as seen in previous settlements, but many were also older. Some were also seen unprotected from animals (*i.e.*, no cattle guard surrounding the access point).

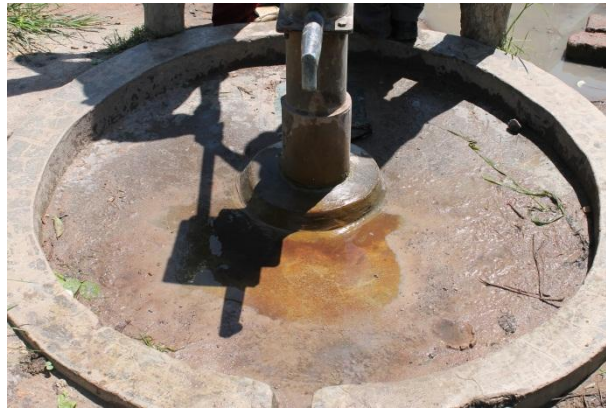
Figure 4.23 Rhino Camp: Discolored concrete around a hand pump

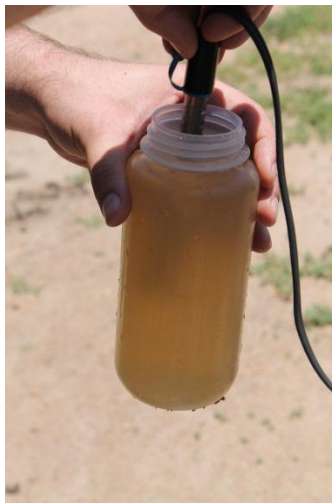
Figure 4.24 Rhino Camp: Discolored well water

A total of 7 samples were collected at Rhino Camp. All sites visited were boreholes. The depths varied, but the maximum depth at a visited site was much deeper than previously seen (approximately 54 m). Discoloration of the water as well as the concrete aprons was observed (Figure 4.23 and Figure 4.24). Some residents complained of a salty taste, as well. Conductivities in the area were observed to be as low as 596 $\mu\text{S}/\text{cm}$ but as high as 805 $\mu\text{S}/\text{cm}$. One point sampled had been abandoned due to *e. coli* contamination.

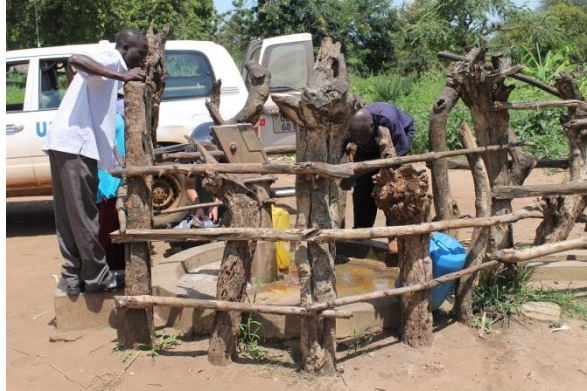
Figure 4.25 Imvepi: Hand-pump borehole

A total of 8 samples were collected at Imvepi. Both hand pumps (Figure 4.25) and tap stands (Figure 4.26) were seen. The protection around the pumps varied. A goat was seen drinking from one hand-pump well, while another was even more poorly protected. Some iron discoloration was seen in Imvepi as well (Figure 4.27).

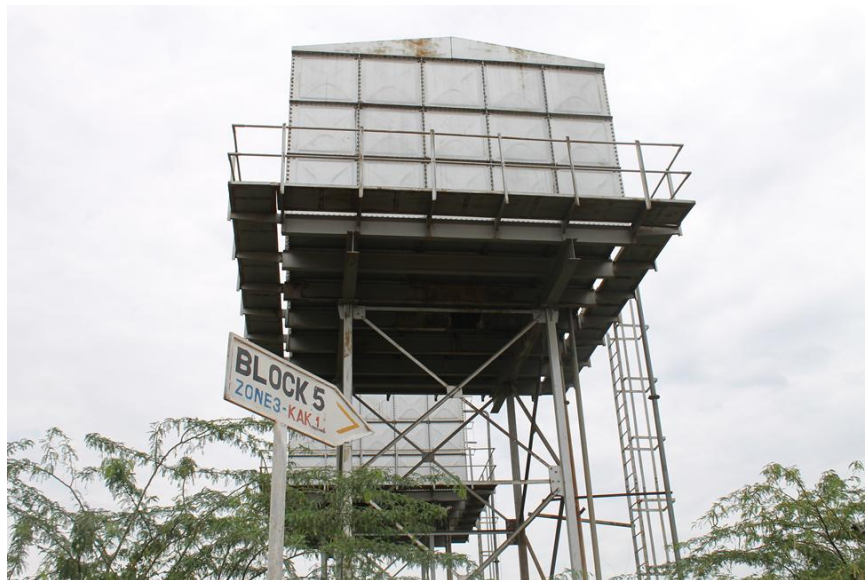
The water system in Kakuma was in general very solid, well-designed, and very efficient. All water was derived from deep boreholes accessed by mechanized submersible pumps. Water in Kakuma was then stored in large elevated tanks (Figure 4.28). Large storage enabled even delivery, and the elevation permitted a gravity-flow driven system.

Figure 4.28 Kakuma: Large elevated water storage tanks

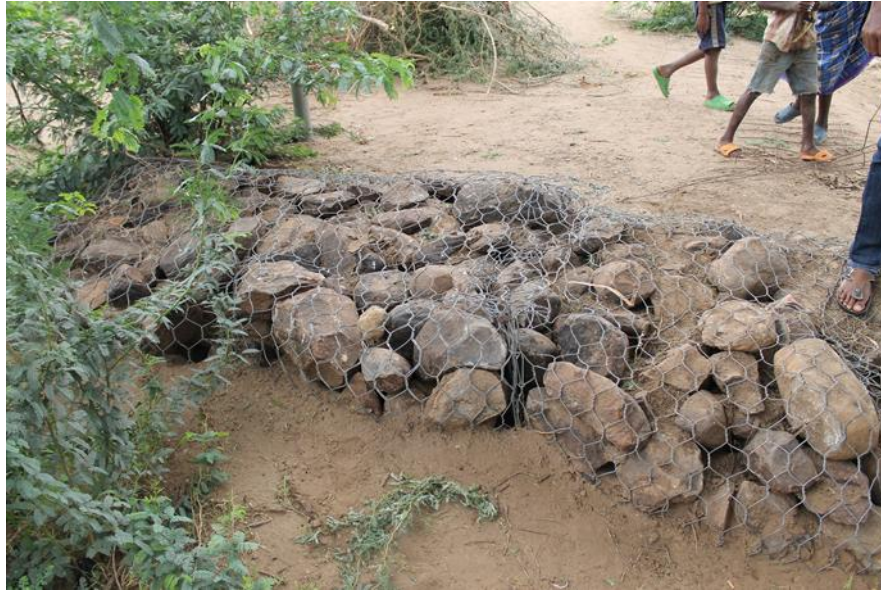
Kakuma had recently experienced significant flash flooding. Numerous sites suffered from heavy erosion from both this event and similar recurrent events in the past. Boreholes near the river edge were protected by erosion control measures (Figure 4.29). If borehole sites had been consumed by erosion, physical damage could be irreversible and the borehole could be forced to be decommissioned. Further, flooding of the site without physical damage could increase the likelihood of down hole contamination.

Figure 4.29 Kakuma: Erosion control near borehole

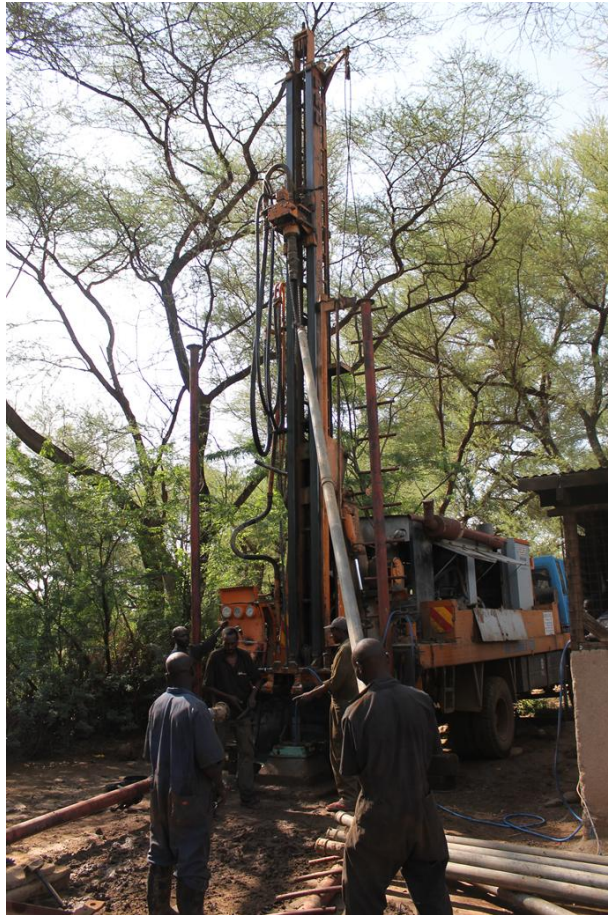
A large revamping of numerous boreholes and the water delivery system was underway. Multiple boreholes were being re-drilled to increase total capacity (Figure 4.30). The current capacity of the system in Kakuma was sufficient, but numerous boreholes were forced to near maximal outputs. This yields a system at risk of failure. If one or more boreholes were to become non-functional due to fuel shortage, generator or other mechanical malfunctions, or the aforementioned physical damage from flash flooding, then the system could become insufficient for the current demand.

Figure 4.30 Kakuma: Drill rig for new borehole construction

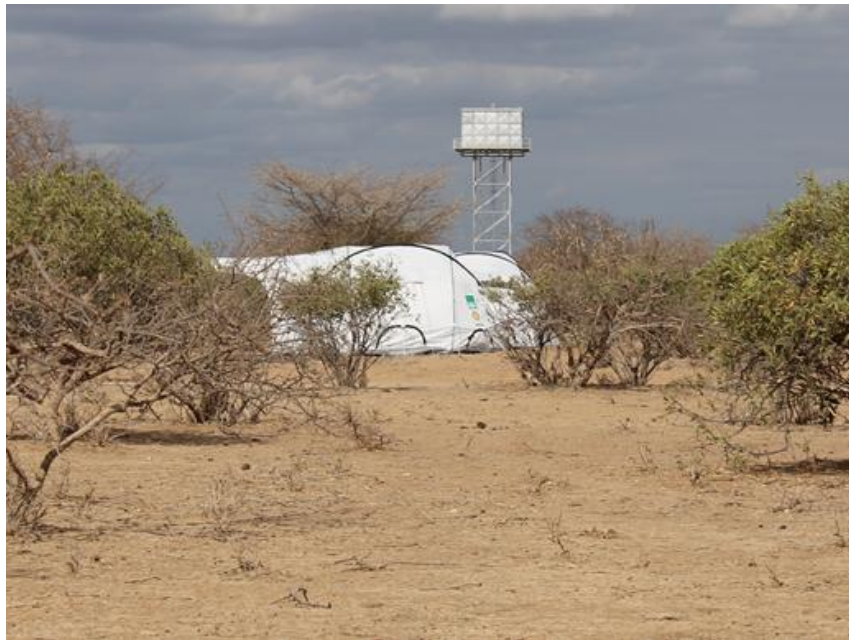
Figure 4.31 Ifo 2: Tents and water tank

extension) for water sampling and field measurements. Ifo 2 was one of the locations the Dadaab area was spreading into. Oxfam was preparing the water system as refugees were being located to the area. At the time, the area was filled with short-term temporary tents that sparsely filled the region (Figure 4.31). Elevated water tanks had already been constructed and stood amongst mostly barren land (Figure 4.31). The implementing partners were clearly ahead of the settling of the area in terms of water delivery. This was fortunate as it mostly prevented the necessity of water trucking for this site.

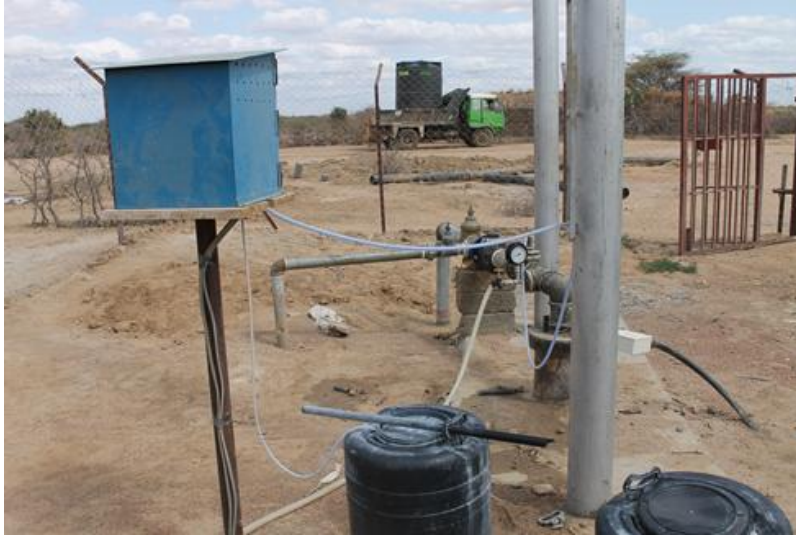
Figure 4.32 Dadaab Camps: Automated chlorine dosing system

Throughout the Dadaab cluster of camps, borehole sites included auto dosing facilities for chlorine additions (Figure 4.32). New construction included these facilities while older sites were retrofitted to include the same.

Sodium hypochlorite solutions were stored in protected cabinets (Figure 4.32) and added to the borehole outflow via small dosing pumps also contained within the cabinets (Figure 4.32). Chlorine addition lines were plumbed directly into the system via small bore tubing (Figure 4.33).

Auto-dosing should help to regulate chemical use (and possible waste), and it should improve dosing consistency. There is the risk of residual chlorine loss during storage. This risk exists with batch treatment but may be more frequent in an in-line system if storage times are inconsistent and occasionally long. As long as regular maintenance of these systems occurs and as long as residual chlorine is routinely measured at taps furthest from the borehole, then the addition of such auto-dosing equipment is an excellent improvement.

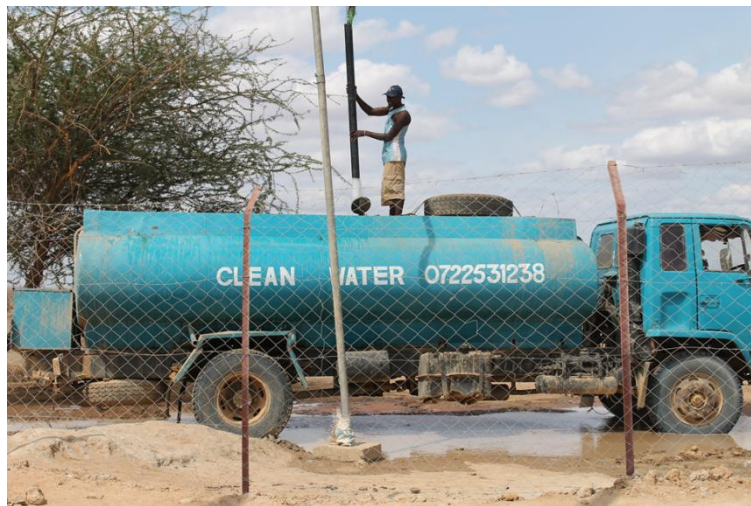
Figure 4.34 Hagadera: Water truck

The following morning Dr. Quicksall proceeded to Hagadera. After a short meeting with CARE Kenya, the team sampled all of the boreholes in Hagadera. Water trucking was necessary during the emergency and was observed in numerous locations including Hagadera (Figure 4.34). Implementing partners were water trucking to the outskirts of camps in the Dadaab region while wells were being rehabbed, new lines were being run, and refugees were moved to more permanent sites.

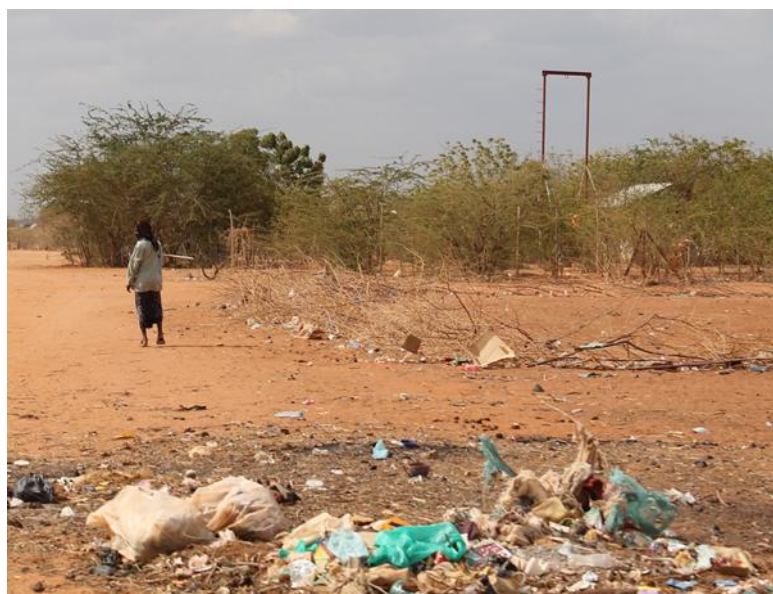
In the afternoon Dr. Quicksall sampled in Ifo. This was the original Ifo camp prior to the addition of the newer extension area sampled the day prior. All boreholes were sampled in Ifo 1. Solid waste was an ever obvious issue in the Dadaab region. While in Ifo, it was observed that large heaps of solid waste, both burned and unburned, were in close proximity to boreholes (Figure 4.35).

Figure 4.35 Dadaab Camps: Solid waste

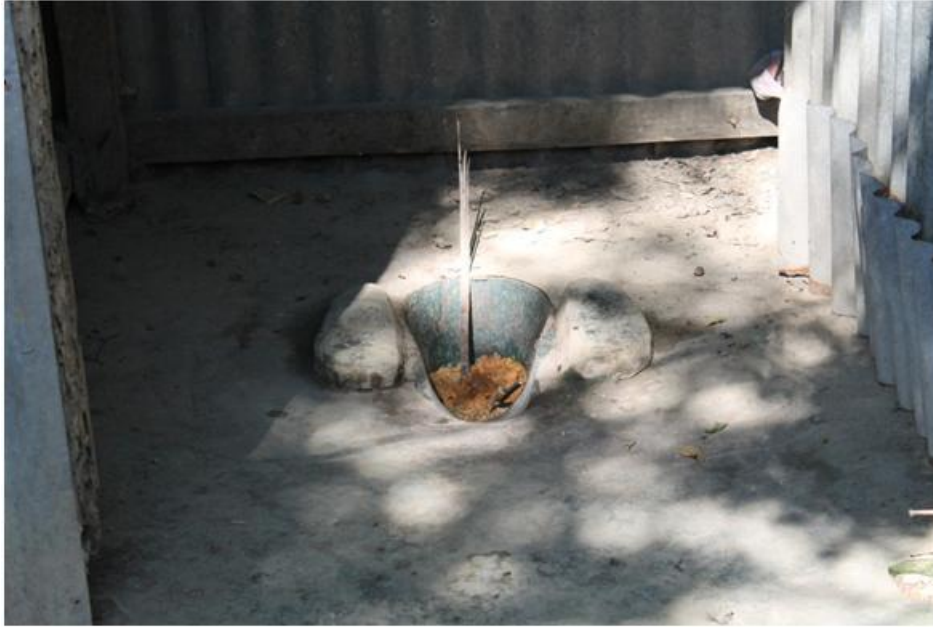
Figure 4.38 Nayapara: Overflowing latrines

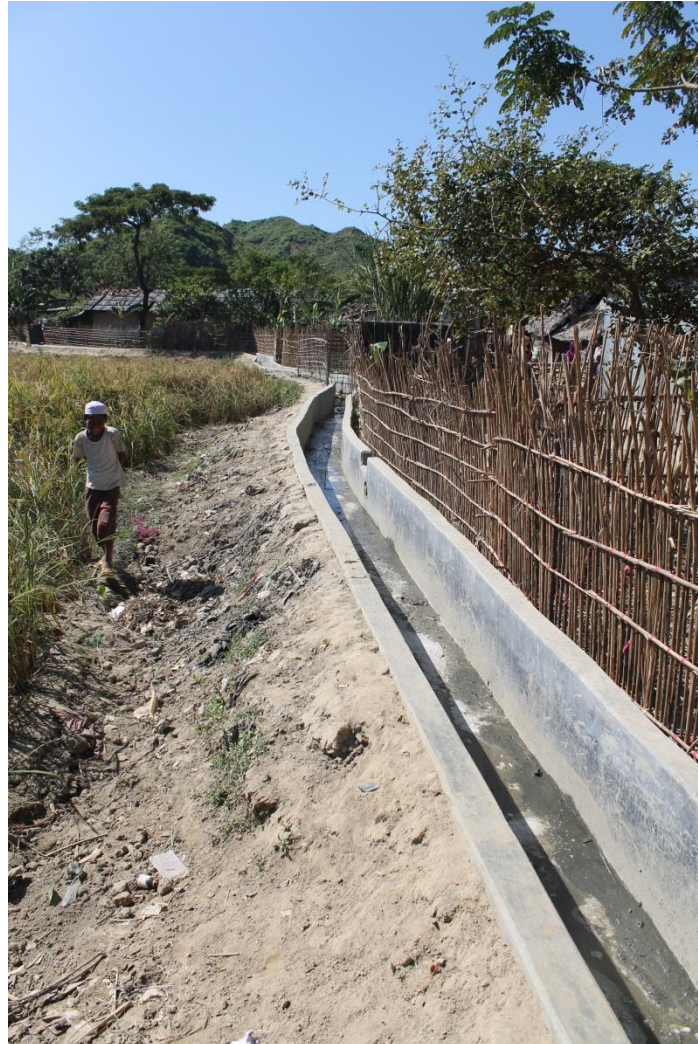
Nayapara had an extensive storm drainage system used in the rainy season for water overflow and control (Figure 4.39). The system was intricate and necessary; however, it seemed, in the dry season, to be used for trash and human waste. There were visible attempts to sanitize these drains through the use of a bleaching product; however, this could become a health hazard as these drains flow back into the water reservoir.

Figure 4.39 Nayapara: Extensive drainage system

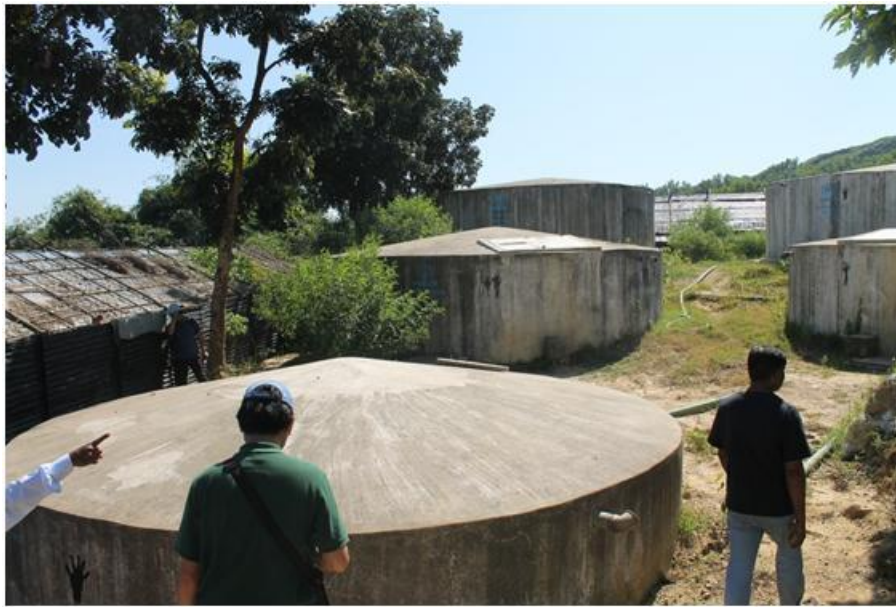
Figure 4.40 Nayapara: Water treatment plant

Water is supplied through a distribution system consisting of three water treatment plants. The main water source was a surface reservoir, which is replenished, in the rainy season. The water is pumped from the reservoir into the three water treatment facilities consisting of a flocculation (aluminum sulfate addition) and a chlorination treatment (Figure 4.40). After the treatment process the water is pumped to distribution tanks where it is distributed to the different blocks in the camps. The water is only distributed during two periods in the day: a morning and evening shift for approximately thirty minutes. This was not observed to be consistent during the team's visit to the camp. Additionally, taps, normally used to control the flow of water, were removed due to theft. Therefore, the refugees have limited access to water, leading to long lines (Figure 4.41) and ultimately water wastage because there is no control of flow when the water is turned on from the main distribution tanks. Because the tap stands were not metered, the exact amount of water flowing to each tank throughout the camp could not be accurately measured. There are 57 water distribution tap stands throughout the camp. It remains unclear whether the refugees are getting the reported amount of daily water for drinking, and it seemed unlikely that each refugee is getting sufficient water for hygiene and cooking.

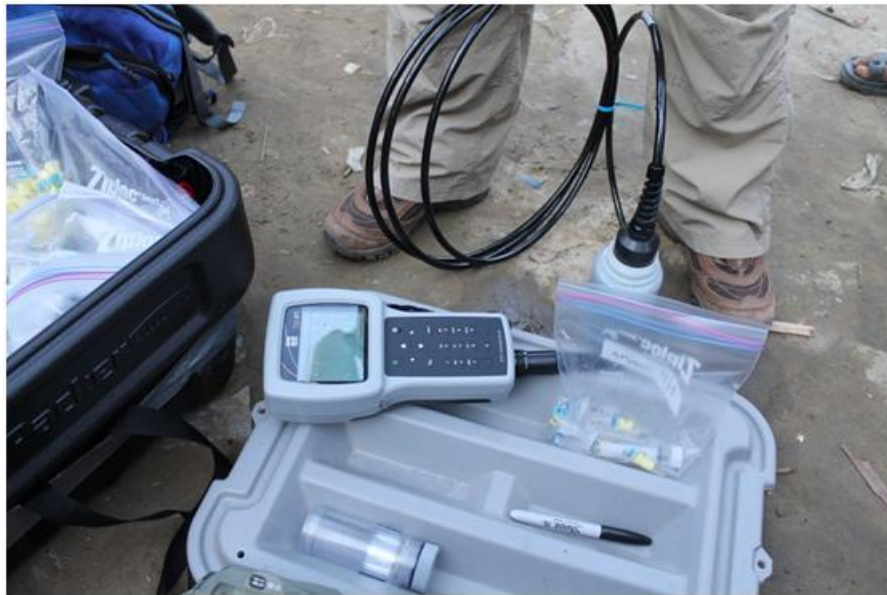
Figure 4.42 Nayapara: The SMU team's sampling equipment

The SMU team's focus was on the quality of water supplied to the refugees. On-site testing was completed using a YSI field meter and probe to measure pH, temperature, dissolved oxygen (DO), conductivity, and oxidation reduction potential (ORP) (Figure 4.42). These initial tests gave a basic sense of overall quality, but four samples were collected to be taken back and analyzed using laboratory equipment. The initial measurements showed circumneutral pH values and low conductivities. Nine sites were sampled in Nayapara: testing each water treatment plant at various stages in the process, as well as water at individual tap stands to test pipeline

contamination. The exact amounts of aluminum sulfate and chlorine added to the raw water were never determined.

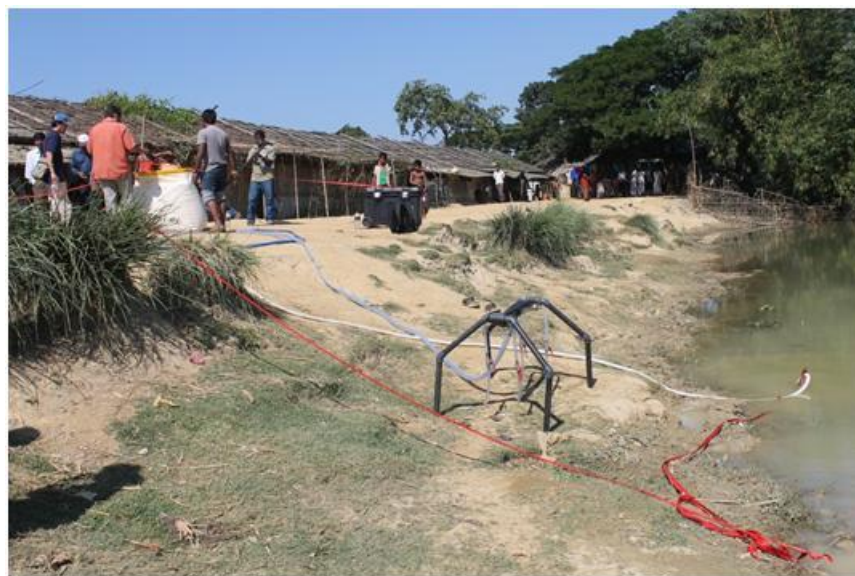
Figure 4.43 Nayapara: Aquasure demonstration

During the mission, a group from the company Aquasure held a demonstration of their product (Figure 4.43). This system was an emergency, portable water sanitation and distribution system used to treat extremely turbid surface waters. The demonstration showed it produced clean water; however, this would be a useful solution primarily in an emergency situation, such as a typhoon or flood, but not a sustainable system for everyday water processing.

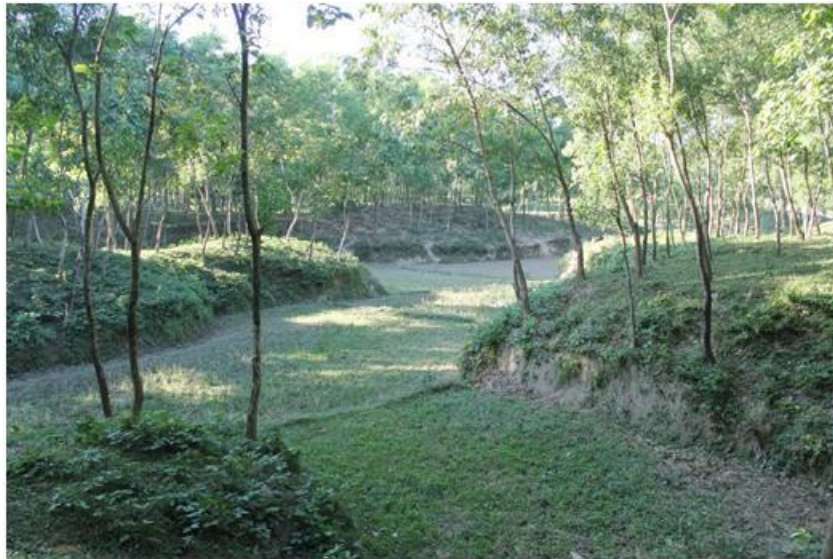
Figure 4.44 Leda: Empty reservoir

The team visited the adjacent ‘unregistered’ camp known as Leda. This camp was in utter crisis at the time of the visit. It was estimated that about 13,000 people were living in Leda at this time. Due to the extreme population densities, refugees had abandoned all latrines and were practicing open defecation off the main road, which led to a severe sanitation problem. However, even more dire, was the lack of water in the camp. The previous season the former NGO had left the camp, so a small reservoir was not dammed in the rainy season as was the yearly custom, leaving it dry (Figure 4.44). There was one large open well that had limited water and a small creek (Figure 4.45) to the back of the camp which would be dry in a few weeks, as at the time of the mission it was the beginning of the dry season. If that reservoir had been filled, then there would have been sufficient water as this camp had the necessary water treatment tanks to distribute water through the camp. No water samples were collected in Leda due to the lack of water. These conditions were almost unbearable to witness.

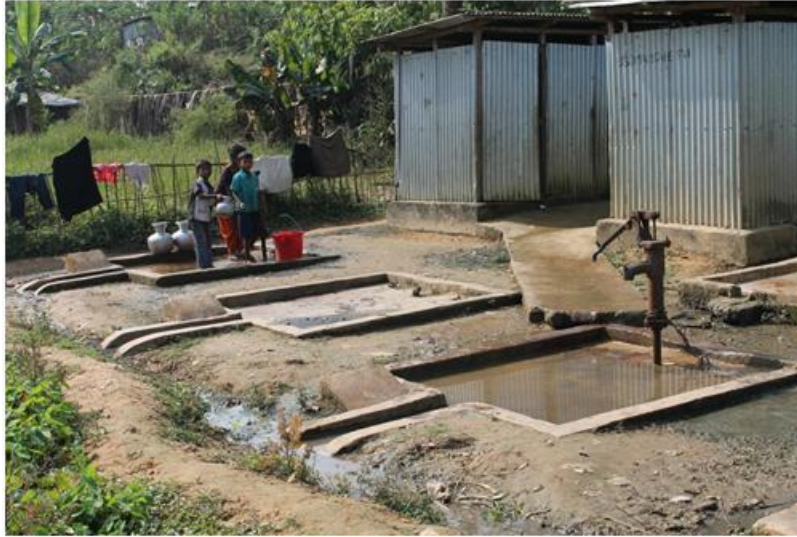
Figure 4.46 Kutapalong: Cluster of wells

The combined team met with camp leaders, but then the SMU team split off to collect water samples, while the team from EAWAG toured the camp. Kutapalong had excellent water coverage, with a total of 107 (97 functioning) tube wells. The SMU team was able to sample 38 wells in a large spatial distribution across the camp area. These tube wells were usually clustered with 2-7 wells in one area (Figure 4.46). This allowed the sampling of more wells in a shorter period of time. The SMU team only had about a day and half for sampling due to scheduling with the other mission. Many times these water clusters were located the required 'walking' distance away from latrines; however, due to elevation changes, the latrines were spatially closer to the water points than reported and many times they were uphill. This is not a likely problem for well contamination since all of the water points are tube wells of sufficient depth; however, drainage toward a water point can possibly be a dangerous sanitary condition. Another observation was that some tube wells were abutting rice fields, the fertilization of which was unclear but suspected. This could lead to potential contamination of nitrate with highly fertilized soils (Figure 4.47).

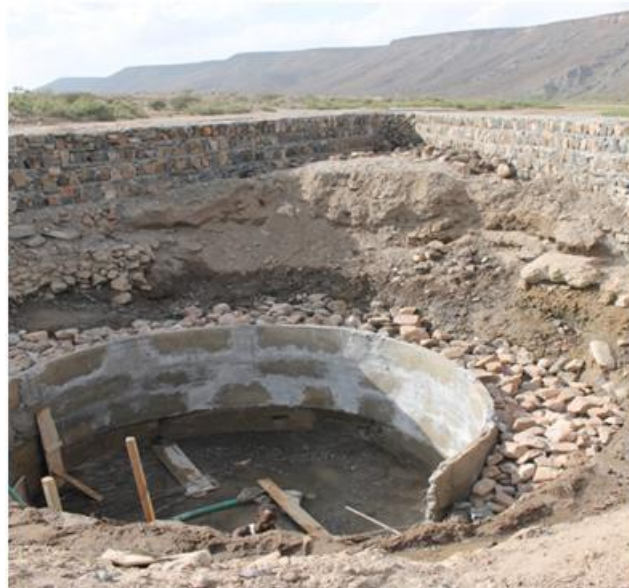
Figure 4.51 Ali Adde: Hand-dug well under construction outside of camp

It was then decided that sufficient time remained in the day to make a trip to the Ali Adde camp for a tour and to obtain general camp and layout information; however, no sampling would take place. Upon arrival at Ali Adde, a 4-m well was seen under construction (Figure 4.51) on the far southwest of the camp in the river channel. It had been dug and was in the concrete phase of construction—building the concrete wall which lines the well. The seemingly great distance to the camp was noted. The seemingly lax working hours of the contracted workers was also noted by the accompanying WASH representatives.

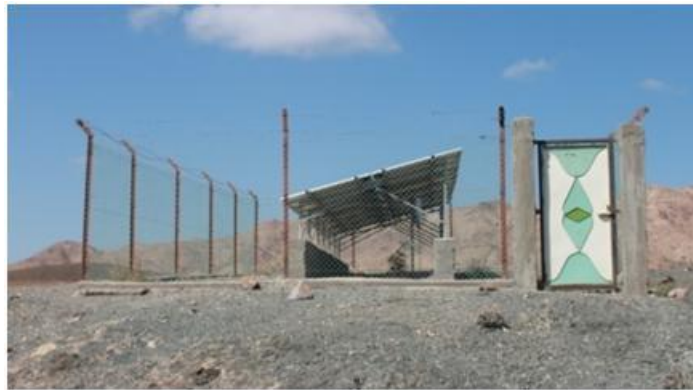
Early in the camp tour, the team noticed solar panels near the 50-m³ batch chlorination station (Figure 4.52). It was explained the original purpose of these solar panels was to power the motorized pump for the borehole adjacent to the panels (borehole 1 yields 3.5 m³/hr but was not functioning; borehole 2 yields 3 m³/hr and was being used to fill the chlorination tank). The panels, however, had been damaged by the refugees themselves despite being surrounded by a chain-link fence with barbed wire—children would throw rocks at the panels—and were damaged to an extent rendering them unusable. The mechanized submersible pump, therefore, was being powered by a generator. In the team's opinion, it seems that if the solar panels can be protected from damage, the pump and chlorination process may be much more efficient. Furthermore, the pumping, chlorinating, and draining of the chlorination tank should be optimized to utilize all resources available (*e.g.*, the solar panels, the storage tank, and the chlorination tank) to their utmost potential. The events should be optimized to provide the most drinking water to the refugees at the most critical times.

Figure 4.52 Ali Adde: Non-functioning solar panels

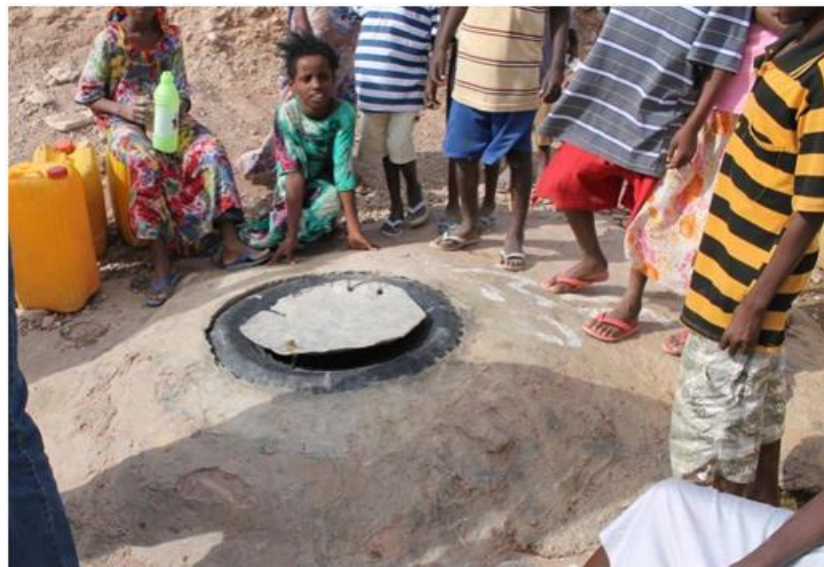
Figure 4.53 Ali Adde: Privately-owned well

As discussed at the debriefing meeting, drinking water access was provided through multiple options. Several 4-m hand-dug wells were seen in Ali Adde camp. A typical capped well is shown in Figure 4.62, although in this figure the hand pumps have not yet been placed on the concrete cap. Another access type seen was tap stands. A tap stand from Ali Adde is shown in Figure 4.63. The other most common drinking water access included private open wells. A typical private open well is shown in Figure 4.53.

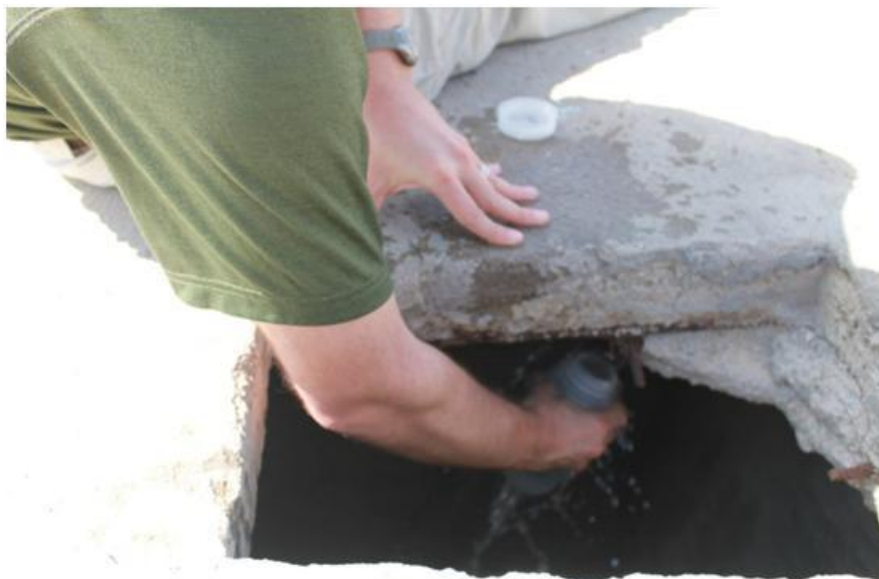
Figure 4.54 Ali Adde: Sampling the batch chlorination tank

Monday was a full sampling day at Ali Adde. The team departed their hotel accommodations in Ali Sabieh around 8:30 AM to commute to the camp, arriving 45 to 60 minutes later. The first sampling site was a hand pump well near the 50-m³ batch chlorination tank. It was seen on Sunday although the motorized pump feeding the tank was not on at the time. The pump was, however, turned on shortly thereafter allowing direct sampling from the water filling the tank from the motorized pumping from the borehole (Figure 4.54).

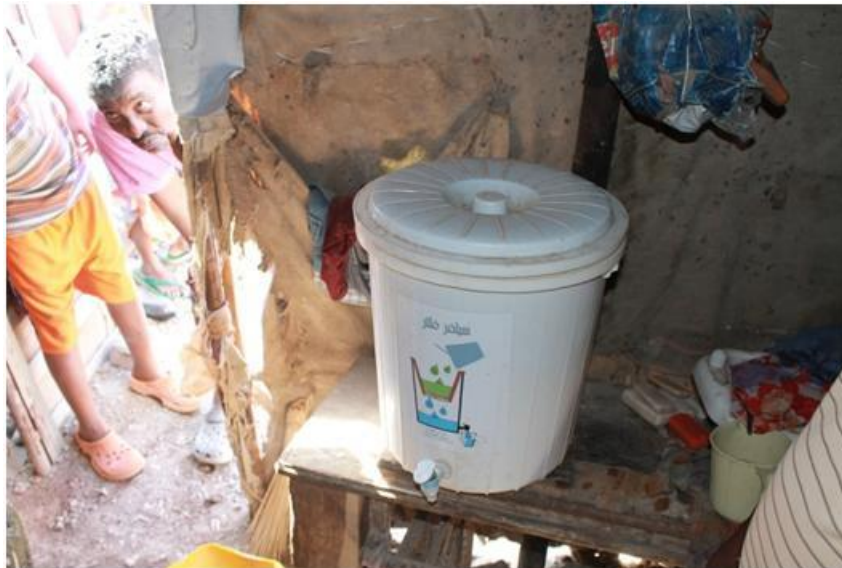
The team also encountered an Ethiopian refugee who was willing to allow sampling of his private in-home ceramic filter (Figure 4.56). Samples were collected both pre- and post-filtration so that filter effectiveness may be observed and reported.

Figure 4.56 Ali Adde: Ceramic filter in a refugee's home
