SMU-UNHCR

Partnership in Research for Water Sanitation
and Hygiene

2011 Final Report

Executive Summary

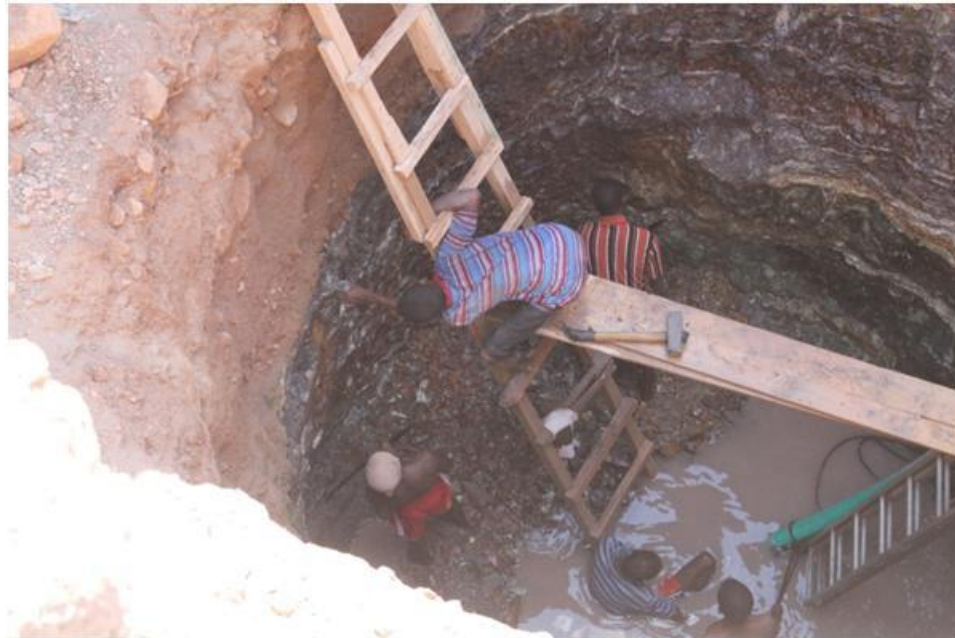
Figure 4.57 Ali Adde: A hand-dug well under construction

Firstly, a site was visited to observe a 4-m hand-dug well being constructed in Ali Adde which was in the digging phase of construction. A sample was taken from the groundwater seeping into the well transversely (Figure 4.57). Gravity-fed tap stands near the southeast part of the camp were also sampled prior to departing the camp.

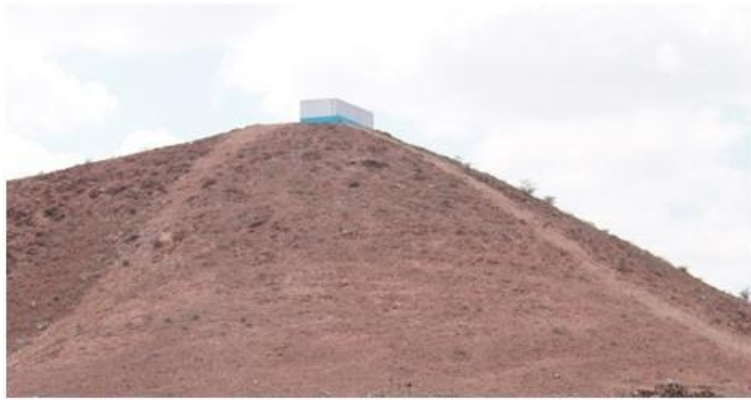
Figure 4.58 Holhol: 100 m³ storage tank

One 100-m³ holding tank had been built on a hill adjacent to the river basin (Figure 4.58). The first samples were taken from a tap from a borehole in the river basin near the previously existing UNHCR tank structures (it became known that Holhol had also been a previously occupied camp). There was also a hand-dug well adjacent to the borehole (covered) which was sampled.

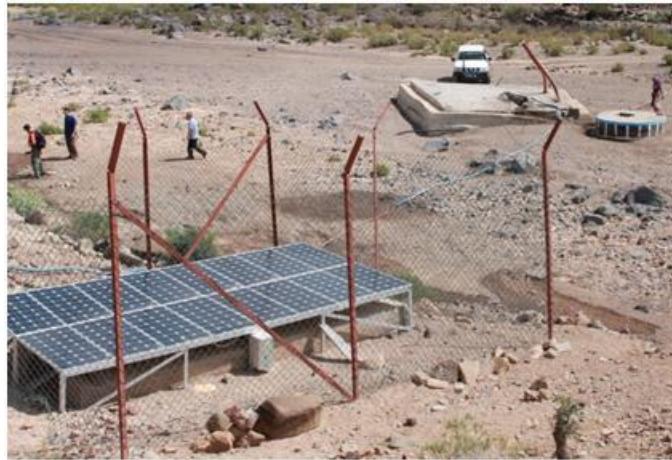
Figure 4.59 Holhol: Existing solar panels

Near the first sampling sites were, like at Ali Adde, solar panels (Figure 4.59). These panels, however, did not look optimized as they were pointed perpendicular to the ground rather than in the appropriate position for the latitude to maximize contact with the sun. Similar to those at Ali Adde, because these are already present at the camp (therefore eliminating the initial capital cost), it seems they should be utilized as a power supply for the adjacent pump to reduce energy use and make the overall operation more efficient.

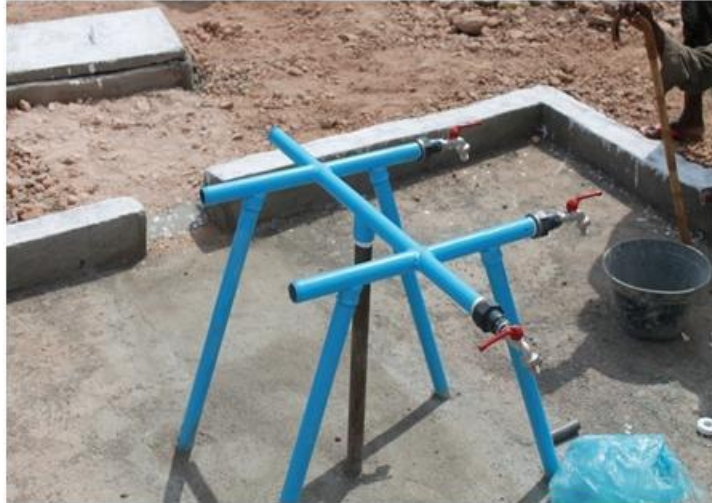
Figure 4.60 Holhol: Tap stand nearing completion

Several samples were subsequently taken along the river basin. These included samples from the privately-owned wells belonging to current area residents in order to get a spatial representation of the area which will soon be providing drinking water to the refugees in Holhol camp. Recently constructed tap stands which will be fed by the 100-m³ storage tank were also sampled (Figure 4.60).

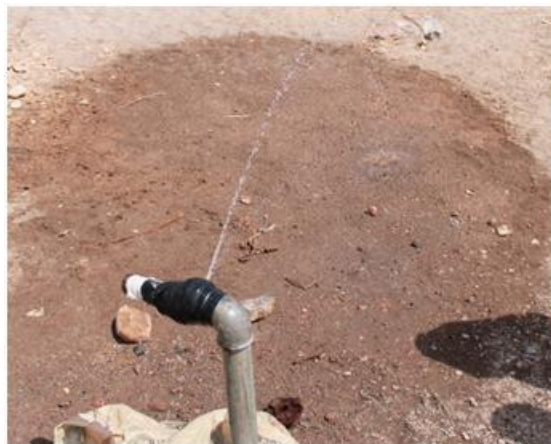
A total of seven drinking water samples were collected at Holhol ranging from the borehole to hand-dug and private wells and tap stands, mostly along the river basin. The quality found during on-site measurements at Holhol camp was similar to Ali Adde; the main parameter to note is conductivity. These were higher than what is normally found in drinking water, as also mentioned for the sampled sites at Ali Adde camp. To reiterate, the common threshold for conductivity in drinking water is 1000 $\mu\text{S}/\text{cm}$; all samples in Holhol had conductivity levels significantly above this threshold. Noteworthy as well is the leaking tap at the initial borehole sampled. The attempted—but ineffective—remedy was tape (Figure 4.61).

Figure 4.61 Holhol: Leaking tap

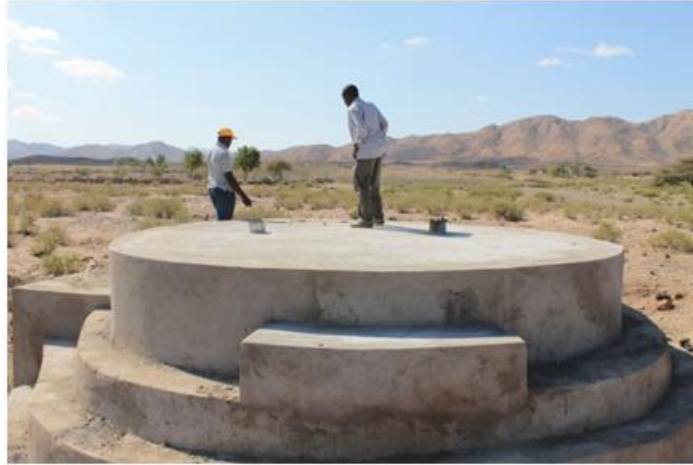
As discussed at the debriefing meeting, drinking water access was provided through multiple options. Several 4-m hand-dug wells were seen in Ali Adde camp. A typical capped well is shown in Figure 4.62, although in this figure the hand pumps have not yet been placed on the concrete cap. Another access type seen was tap stands. A tap stand from Ali Adde is shown in Figure 4.63. The other most common drinking water access included private open wells. A typical private open well is shown in Figure 4.53.

**Figure 4.62 Ali Adde: Typical capped 4-m hand-dug well
Hand pumps yet to be placed**

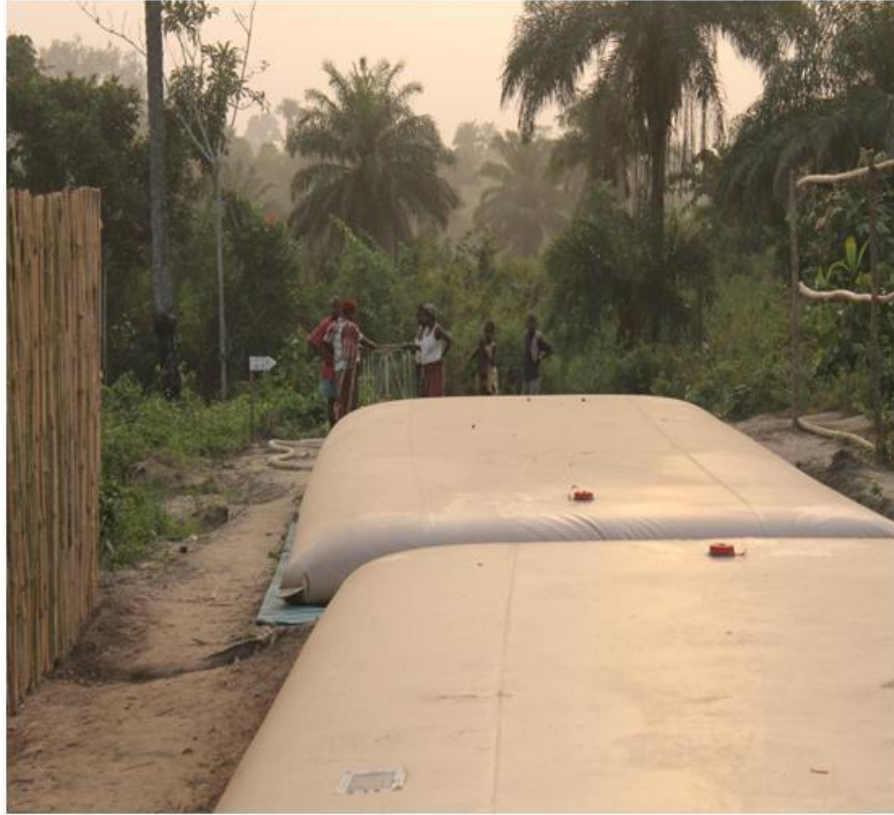
The mission team arrived at Bahn camp at around 3:30 PM. At the time, Bahn was shelter to about 5,000 refugees but had a capacity to hold 15,000 people. Most of the refugees are from Cote d'Ivoire seeking asylum after the unrest that followed the presidential elections in November 2010. Four wells were tested in total. Submersible pumps were used to pull the water out of the well using a generator. The water was then stored in a tank or a large storage bag where it might be chlorinated and then distributed to the taps (Figure 4.65). Water distribution from these taps had to stop during pumping which could take up to 9 hours. All the camps that were visited had outside communal latrines and showers, which were each shared by 12-20 refugees. The latrines were located at least 30 m away from the wells to prevent contamination of the water. The driver had to report back to the UNHCR office by 6 PM, so the SMU team headed back to Saglepie at 5:30 PM.

Figure 4.65 Bahn: Large water storage bags (front right) connected to taps (back center)

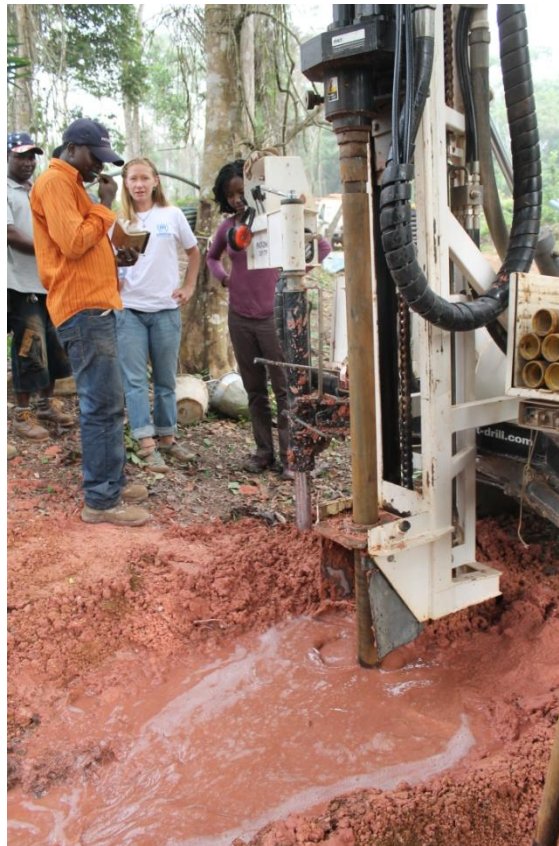
Figure 4.67 Dougee: Well under construction

A UNHCR driver picked up the SMU team at 7:00 AM at the UNHCR guesthouse and headed to Dougee located in Grand Gedeh County. This camp has a capacity of about 10,000 persons and was at only half capacity at the time. The UN staff at Dougee camp explained that it was difficult to distinguish Liberian natives from the refugees and that there might be hundreds of Liberian natives already living in the camp. Some of the refugees who lived in temporary shelters (Figure 4.66) tried to make it more convenient by adding extensions made of pine branches. The yield from the wells that were tested was good. The water at a creek adjacent to the camp was tested because there were plans to construct a new well close by. A new well, walking distance from the camp, was under construction (Figure 4.67).

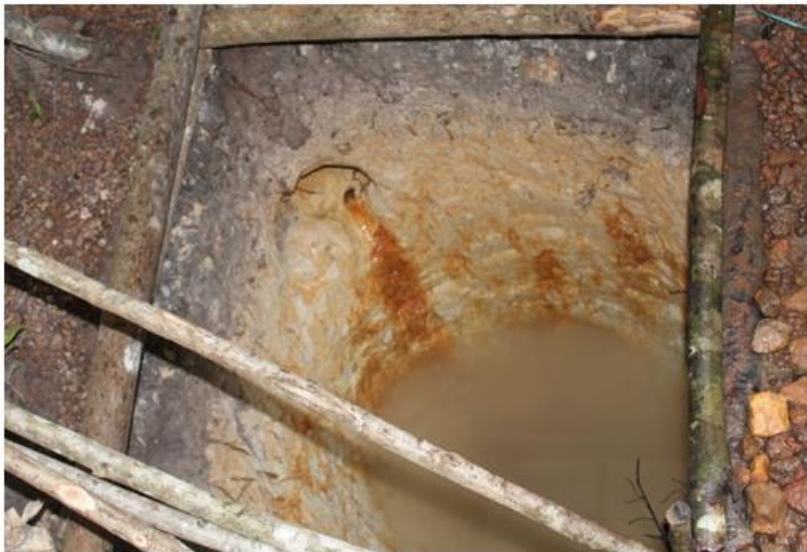
Although the visit to PTP camp had been cancelled due to the delay in starting the mission, the team decided to conduct an early-morning visit to the camp on Wednesday. Three wells were tested in total. The refugees constructed a hand-dug well at this camp (Figure 4.68). They explained that they prefer the water from this well because the water was cooler and tasted better than the water from the other wells. After numerous failed attempts to try to stop the refugees from using water from this well, the WASH team leader required that all the water collected from the hand-dug well must be chlorinated with aquatabs on site to lower risk of disease.

Figure 4.68 PTP: Hand-dug well

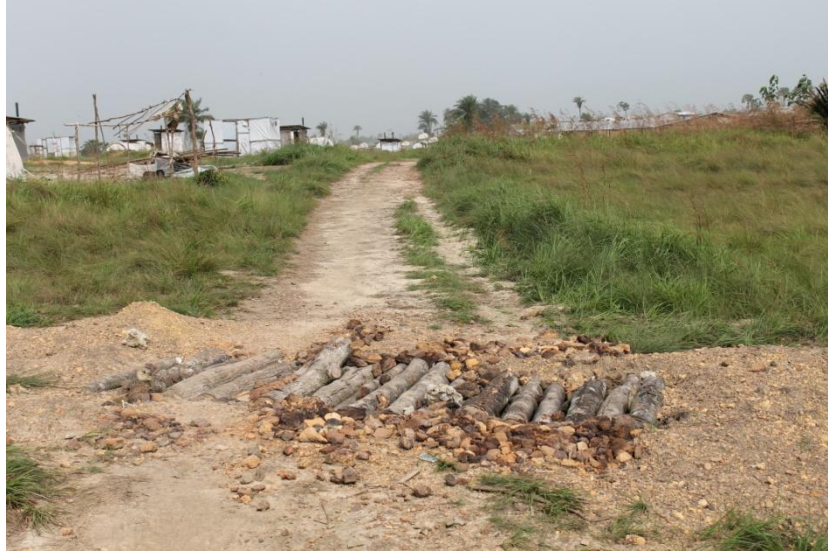
Figure 4.70 Little Wlebo: Flood trenches

Nine wells in total were sampled at Little Wlebo. One could immediately see that the flood trenches (which were dug to prevent the homes from being flooded during the rainy season) at this camp were more advanced compared to the other camps (Figure 4.70).

These flood trenches were thankfully covered and will hopefully prevent numerous diseases. Each well had its own number for easy identification, and the yield from these wells was good. The engineer also included concrete slabs (Figure 4.71) to help with hand washing.

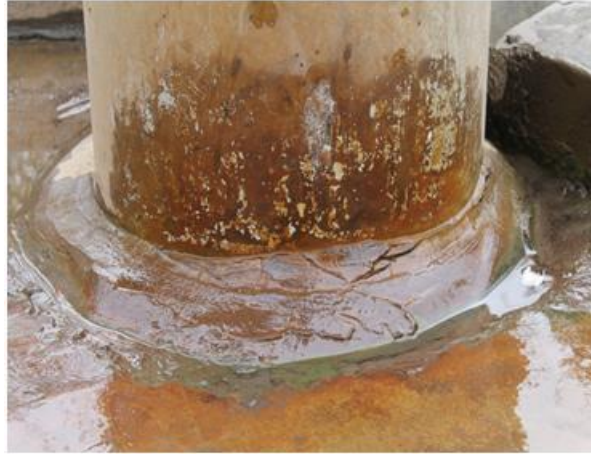
Figure 7.1 Nakivale: Red staining shows excess iron in drinking water source

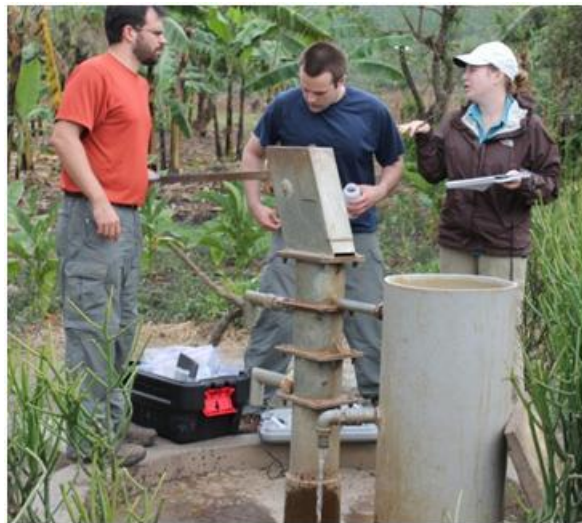
Figure 7.2 Nakivale: Iron filter on hand-pump drinking water well

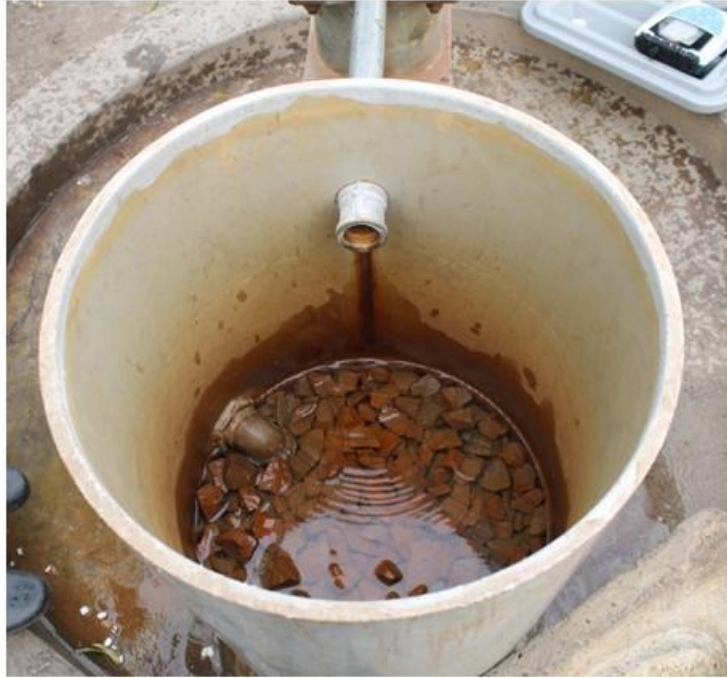
Figure 7.3 Nakivale: Filtration system currently in use
Components are a simple PVC tube cemented to the ground and large rocks

Figure 7.3 shows the current configuration of the iron removal system in Nakivale. The red coloration of the water and of the PVC pipe is a good visual indicator of the high iron concentration. Rocks are simply resting at the bottom and quickly accumulate iron, calling for frequent changing and cleaning. This maintenance is performed by volunteers in the community, but several accounts were gathered that these attempts are quite difficult to coordinate because of the frequency with which it must be done and because it is a time-consuming task.

Of the refugee camps that the SMU team visited, two already have some attempts at iron removal through rock filters. This is encouraging because it shows that the community is concerned about the high iron levels. While the rock filters remove some iron, they do not remove sufficient iron to produce water at a safe level or at a level that has a good taste. These filters are also not easily maintained. The rocks accumulate iron quickly, and cleaning is time-consuming and inefficient. At the two locations observed by the SMU team, the filter barrels were made out of large 18” PVC pipe, such as that shown in Figure 7.2 and in Figure 7.3, or made out of concrete. Both locations had lids.

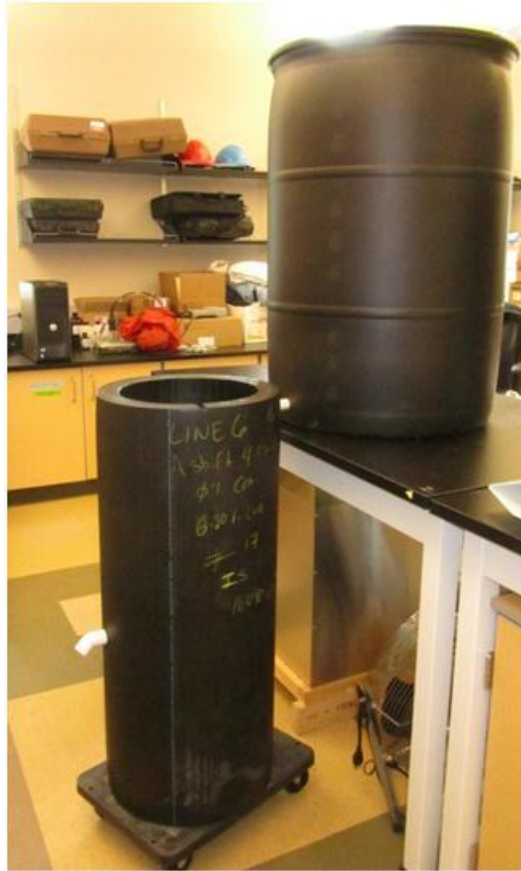
Figure 7.4 Laboratory iron filter prototype
Barrel (on table) supplies synthetic groundwater spiked with varying levels of iron to the polyethylene tube (on floor), which serves as the housing for the iron filter

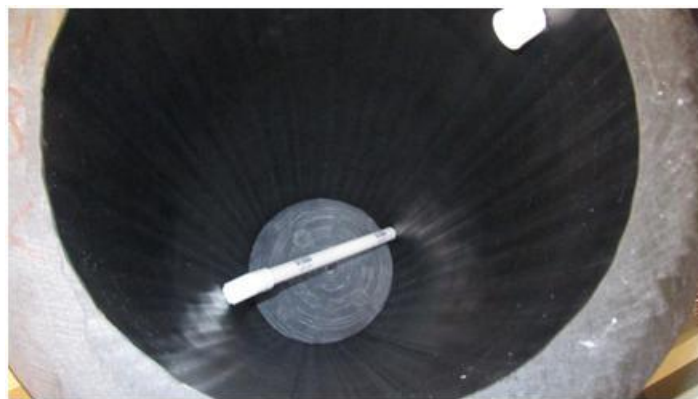
Figure 7.5 Laboratory iron filter housing
Water drains through the pipe at the bottom; filtration will occur on a component attached to the lid

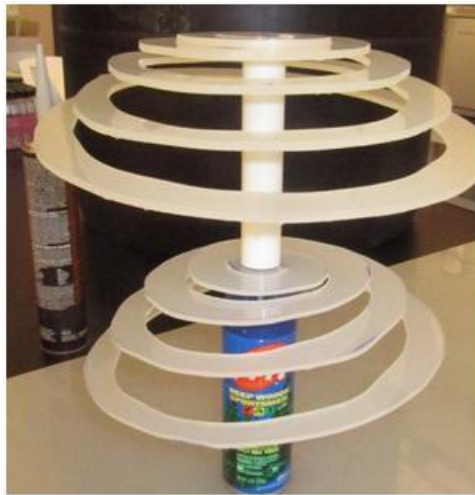
Figure 7.11 Laboratory iron filter: Disk prototype
Polypropylene spirals in expanded position, made in the SMU Quicksall lab
Disks will have three sizes in order to stack and maximize space usage

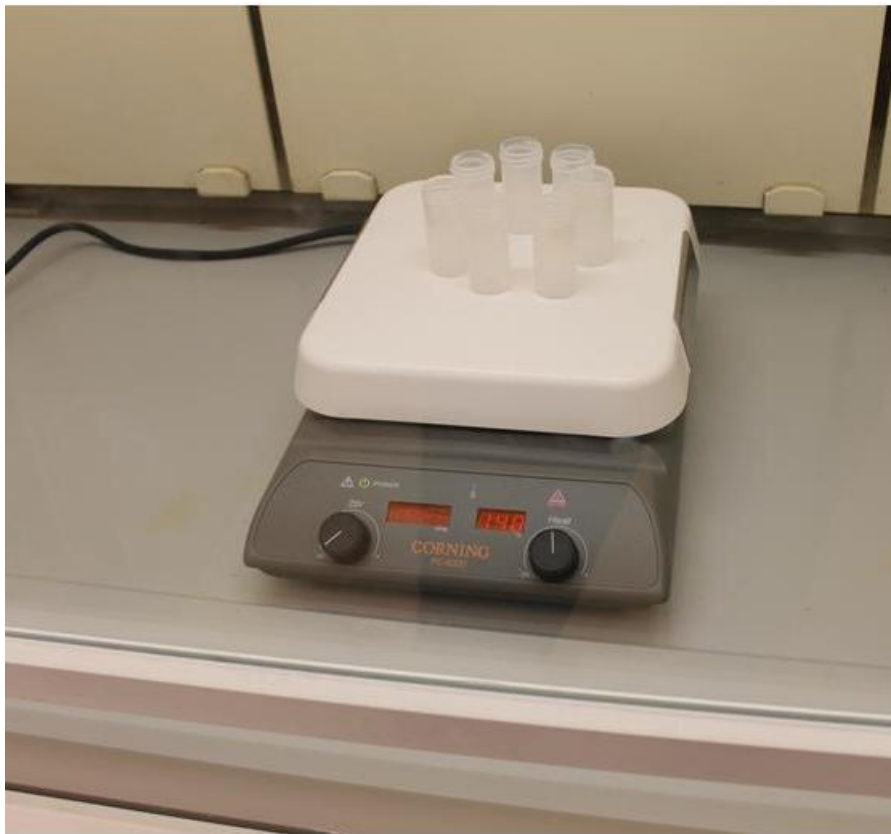
Figure 8.1 Teflon vials on the hot plate for digestion

Methods are currently under development, but the preliminary procedure is as follows. Unacidified, unfiltered raw water samples are collected at each sampling location. It is necessary to remove the suspended particulate matter from each sample and use acid digestion to dissolve the SPM for laboratory analysis. In the lab, 5-10 mL of each raw water sample is filtered with 0.45 μm filter paper using a reusable filter holder. The filter paper is removed from the filter holder and placed into a 30 mL Teflon vial. 15 mL of reverse aqua regia (RAR) is added. RAR is made up of 1 part concentrated HCl and 3 parts concentrated HNO_3 (all acids are trace metal grade from Fisher Scientific). Under a vented hood, the vials are placed on a hot plate (Figure 8.1), which keeps the RAR temperature at $\sim 75^\circ\text{C}$. The samples are digested until all of the liquid has evaporated (Figure 8.2). If necessary, the samples are re-digested a second or a third time. Digestion of each sample can take up to 10 hours. The digested samples are then re-dissolved in 5% HNO_3 and analyzed with ICP-MS.
